PARTIAL REPLACEMENT OF THE GRANULAR LAYER AT THE BOTTOM OF A LANDFILL: SHORT AND LONG TERM MONITORING OF DRAINAGE GEOSYNTHETICS

Abstract: Landfill owners use more and more renewable resources by substituting the granular layer with a drainage geocomposite in landfill covers. A greater demand concerns the bottom of landfills where usually a layer of 50 cm of gravel should be placed. The paper presents an experimental study where the granular layer has been partially replaced by a geocomposite equipped with mini-pipes directly laid onto the geomembrane. The geocomposite aims at acting as a drain and also at protecting the geomembrane against puncture. In order to check the efficiency of the product used, a video inspection has been done during the reception of the waste up to about 15 metres height. A test pad has also been constructed to estimate the impact of the granular layer thickness reduction on geomembrane exposure to puncture damages. The present study highlights critical steps during the construction of the landfill bottom layers and suggests a methodology the drainage and puncture protection functions of the geosynthetics.

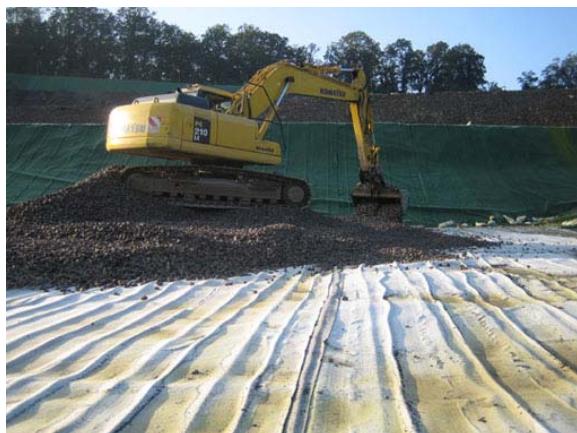
Figure 1. Putting into place of gravel on the geocomposite

The experiments have been conducted on a hazardous waste landfill during 7 months. A geocomposite with incorporated mini-pipes has been laid directly on the geomembrane, continuously welded with hot air to avoid displacements during backfilling and covered with 0.30 m of crushed gravel material 20/40 mm (Figure 1).

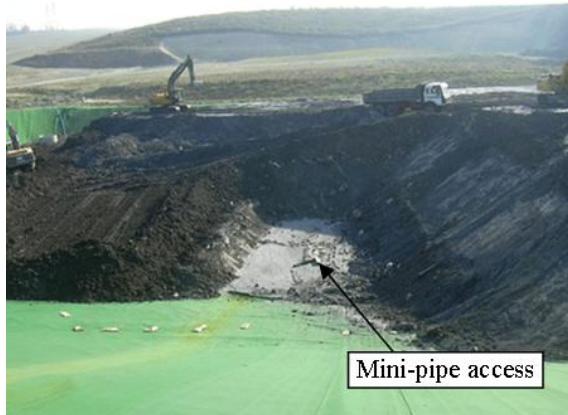
Figure 5. Filling with waste around the test pad

The access to mini-pipes was possible thanks to an open space left in the middle of the waste as shown in Figure 5.

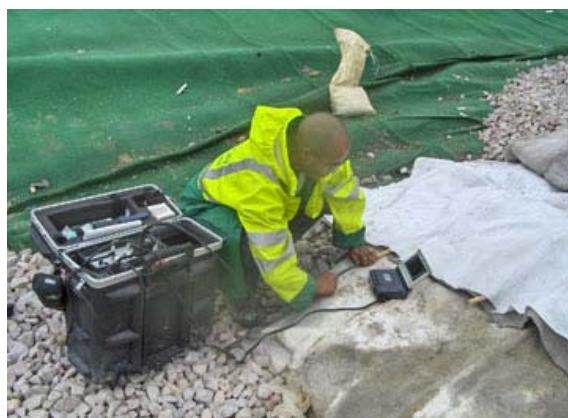
Figure 6. Insertion of the endoscope into the mini-pipe

The experiments consist of introducing an endoscope video camera into the mini-pipes of the geocomposite and check if there is any damage on them. The camera allows also to see the leachate drainage by the geocomposite.

Video inspection has been conducted by a third party inspector. Viewing inside mini-pipe is possible thanks to an arc lamp on the endoscope camera. The endoscope has a diameter of 8 mm (see figure 6). Video is seen directly on a screen during the inspection.

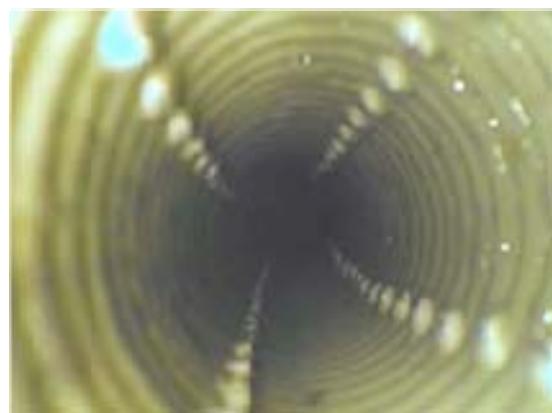
Figure 7. Mini-pipe free of damage

- Deformation of the mini-pipe from 0% to 30%: considered as free of damage (see figure 7),
- Deformation of the mini-pipe superior or equal to 30%: mini-pipe damaged (see figure 8).
